Using Aerial Videography to Assess Riparian Areas in Southern Alberta

A PILOT STUDY

Using Aerial Videography to Assess Riparian Areas in Southern Alberta: A Pilot Study

Alberta Environment
Southern Region
Calgary, Alberta

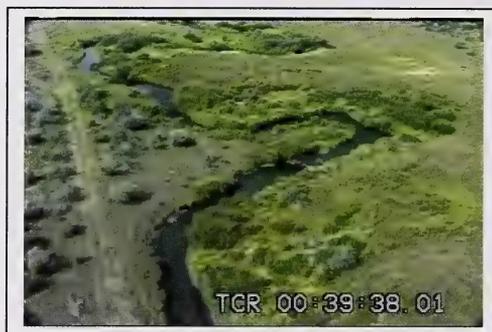
Figure 3. Todd Creek

Viewing angles included both banks (Figure 3), except for the Bow River where left and right banks were video-taped separately (Figure 4).

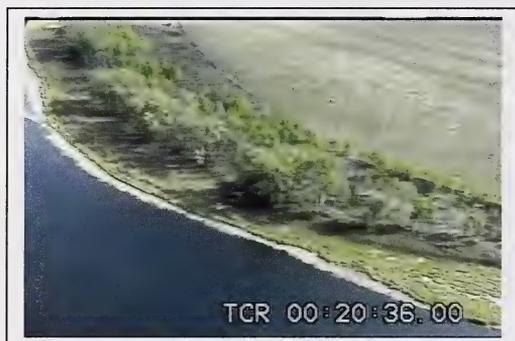
Figure 4. Bow River

Overall, the quality of the videos was adequate for identification of ground details such as cattle grazing and vehicular activity (Figures 4 & 5).

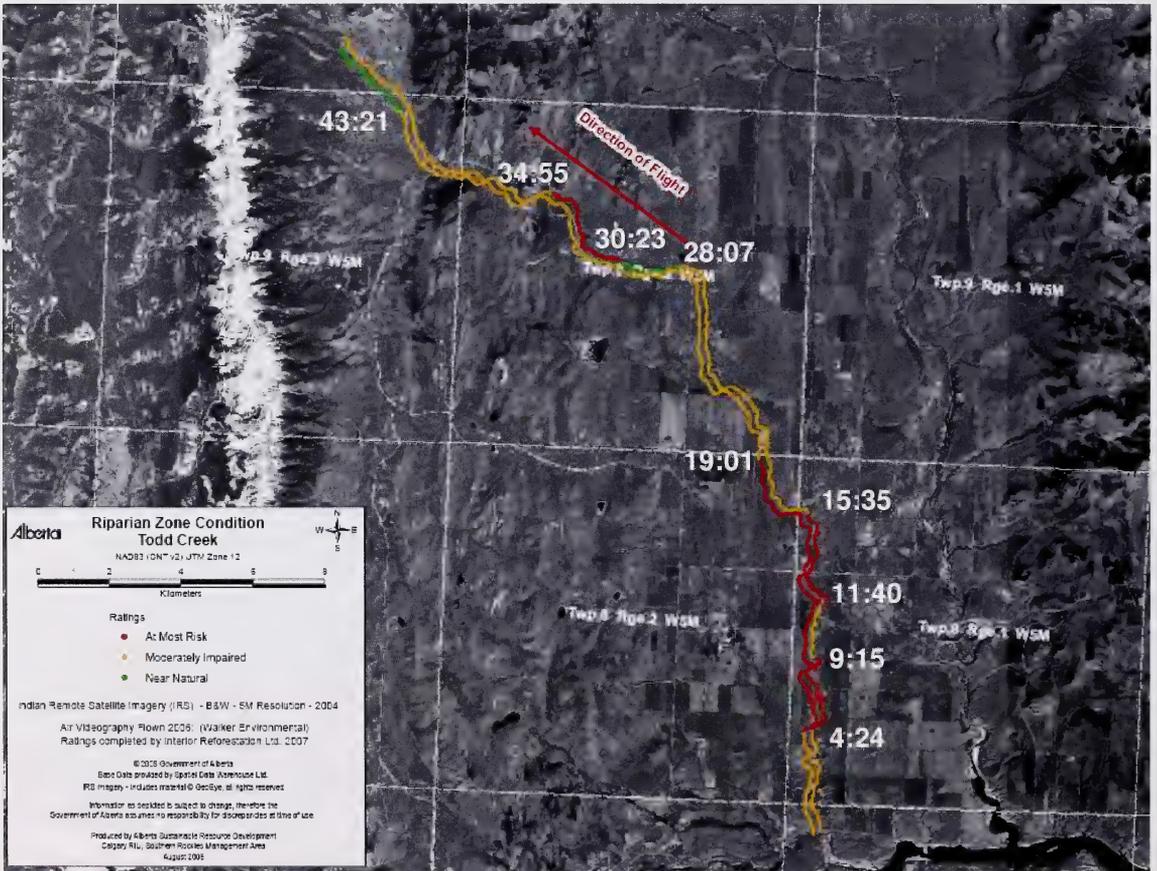
Todd Creek

Reach Flow: From its confluence with the Oldman River to the southeastern part of Twp 10, Rge 3, W5M in the Rocky Mountains Forest Reserve.

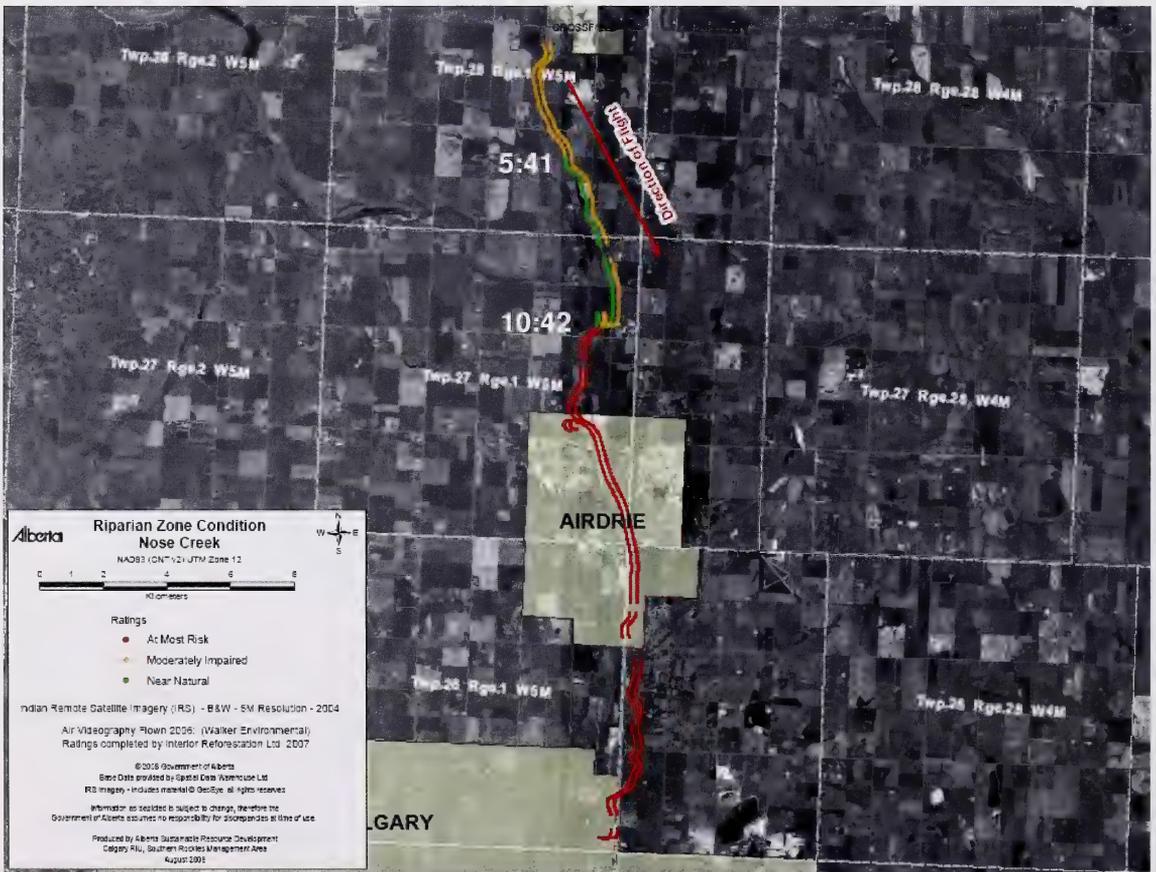
Nose Creek

Reach Flow: From its source west of the Town of Crossfield to near its crossing with the Calgary city limit.

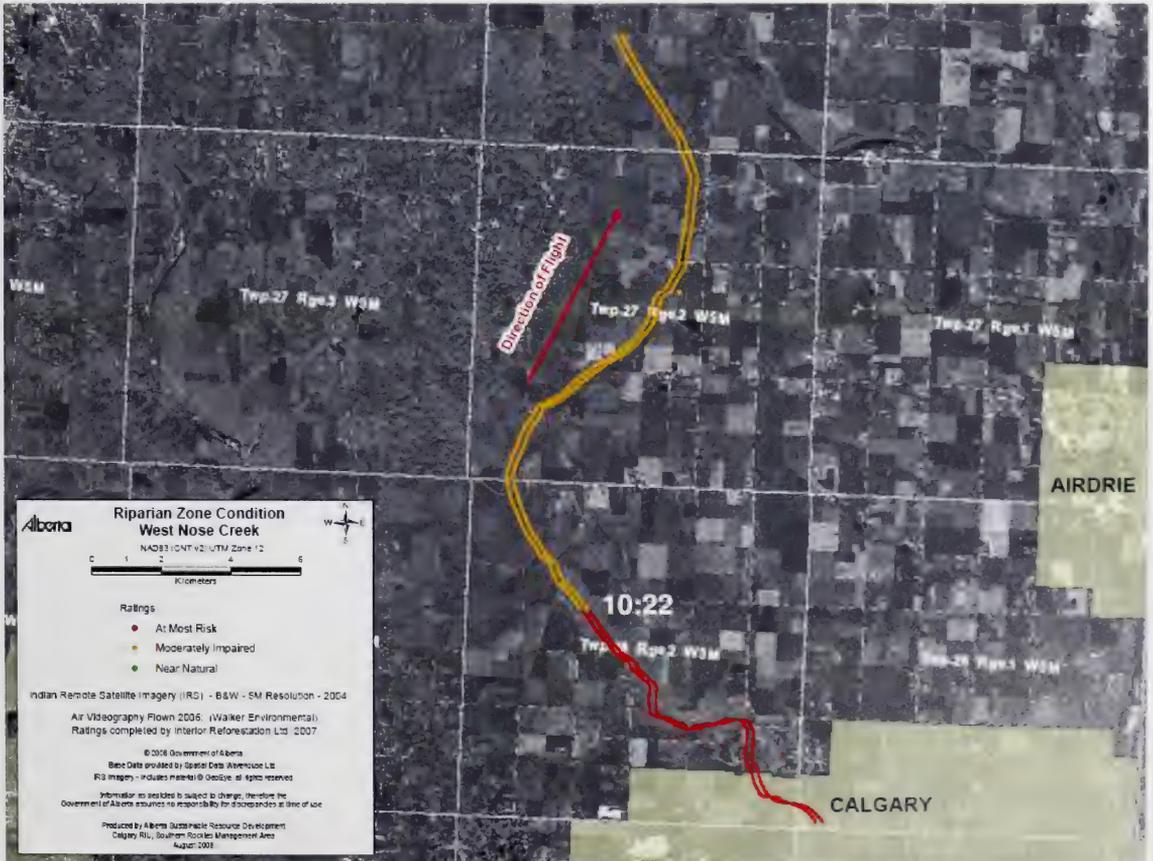
West Nose Creek

Reach Flown: From near its crossing with the Calgary city limit to near its source in Twp 28, Rge 2, W5M.

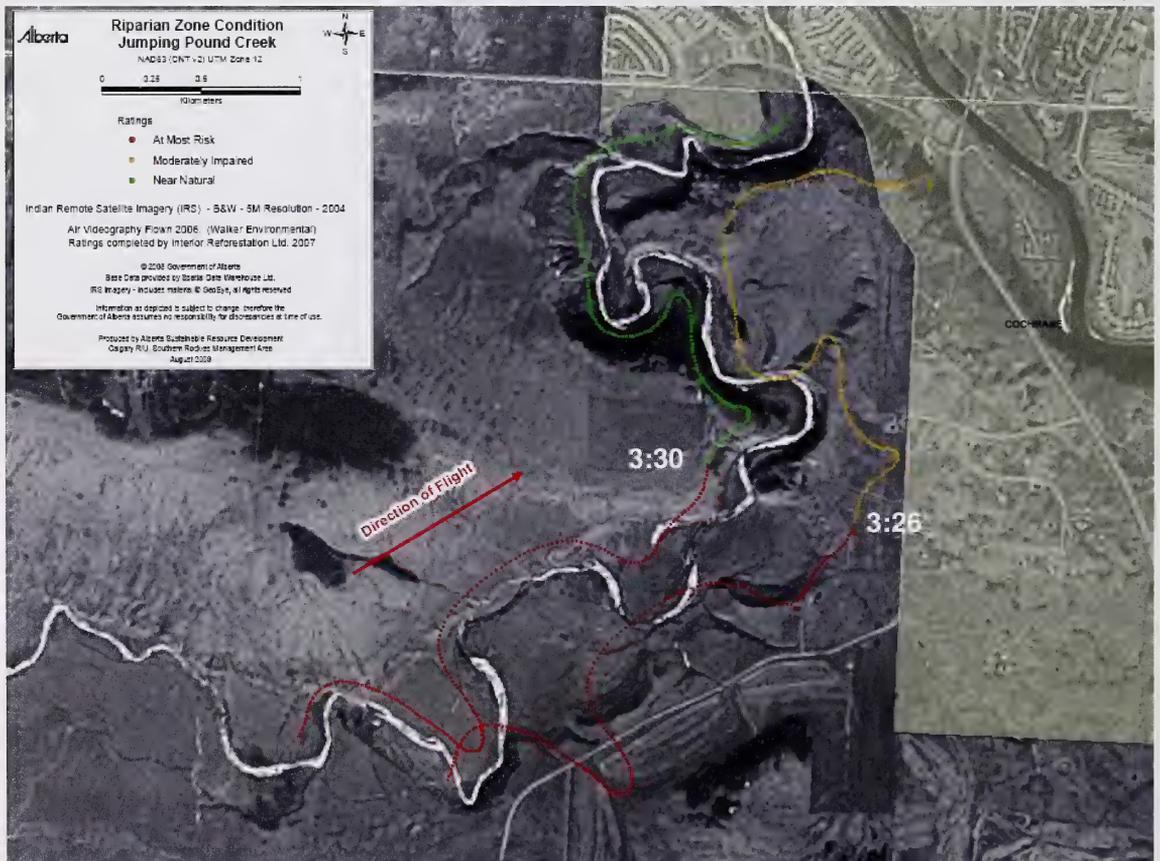
Jumpingpound Creek

Note: The unusual location of the riparian area line on the right bank of the creek is due to scaling errors induced during the offset-process.

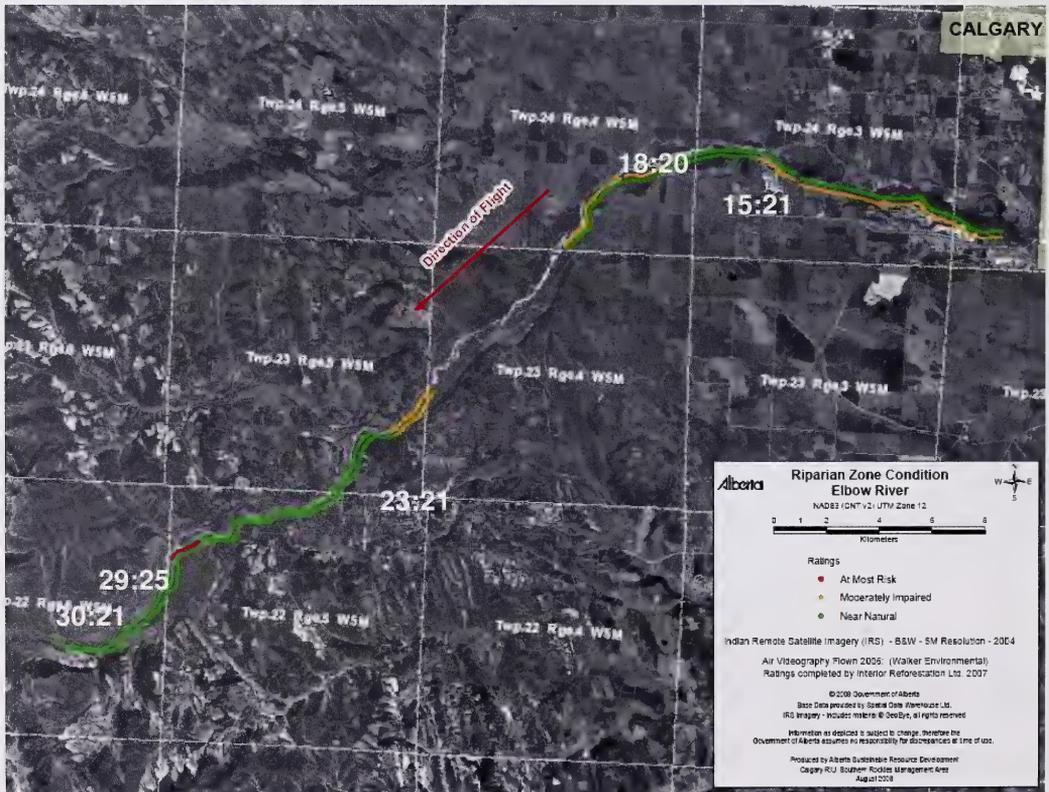
Elbow River

Note: The gap in the scoring corresponds to the Tsuu T'ina Nations Reserve Lands where the video camera was turned off.

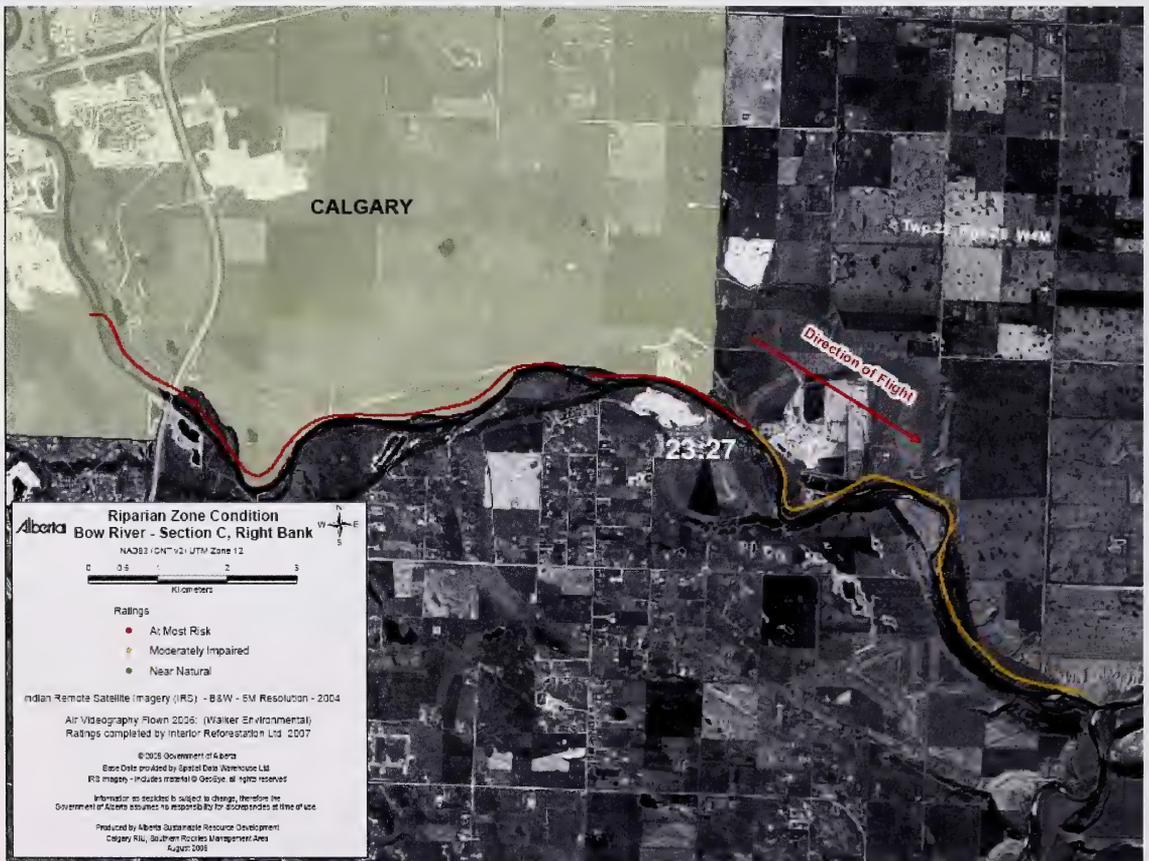
Bow River - Section C, Right Bank

Reach Flow: From near its crossing at the Calgary city limit to its confluence with the
Highwood River.
